**NL INDUSTRIES/TARACORP SUPERFUND SITE GROUP**  
**2209 Quarry Drive, Suite C-35**  
**Reading, PA 19609**  
**Telephone: (610) 670-7310**  
**Facsimile: (610) 670-7311**

December 1, 2020

**Re: NL Industries/Taracorp Superfund Site; Granite City, Illinois**  
**Second 2020 Semi-Annual Operation and Maintenance Inspection (November 9, 2020)**  
**Annual Site Visit (November 10, 2020)**

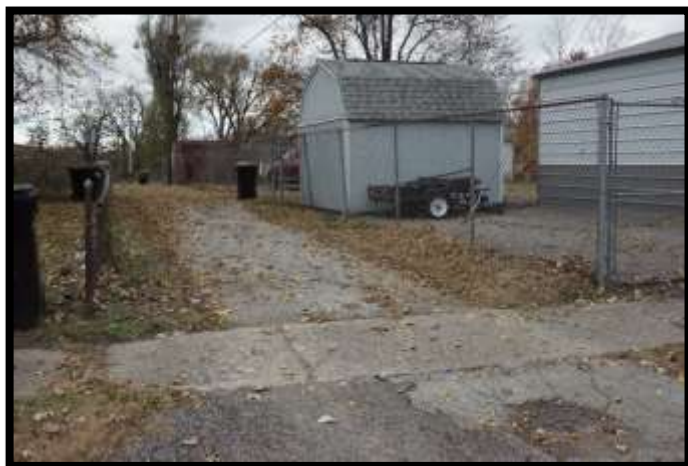
Photograph 9: Alley between Jefferson Street and Washington Street (view southwest from 6<sup>th</sup> Street); repairs at end of alley.

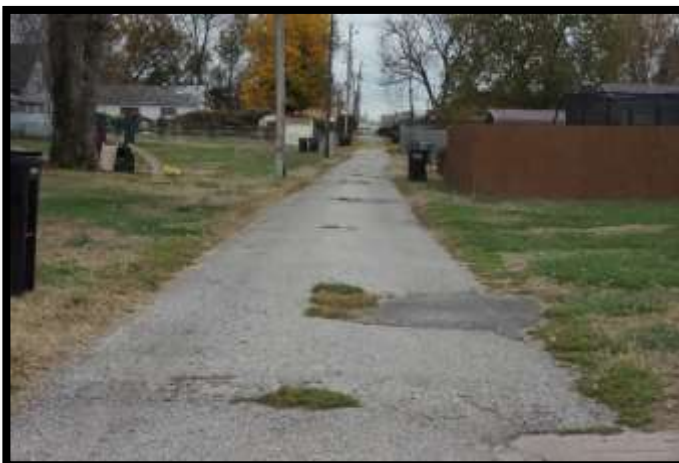
Photograph 14: Alley between Market Street and Logan Street (view east from Meredocia Street); repairs shown.

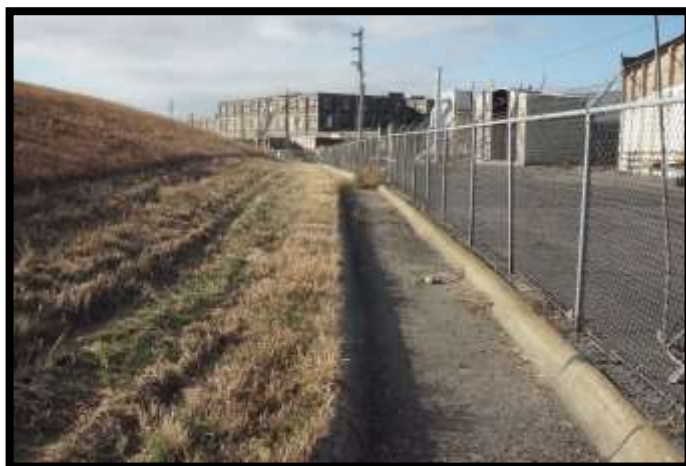
Photograph 16: Concrete drainage swale, crack in concrete along northwestern side of Taracorp pile.

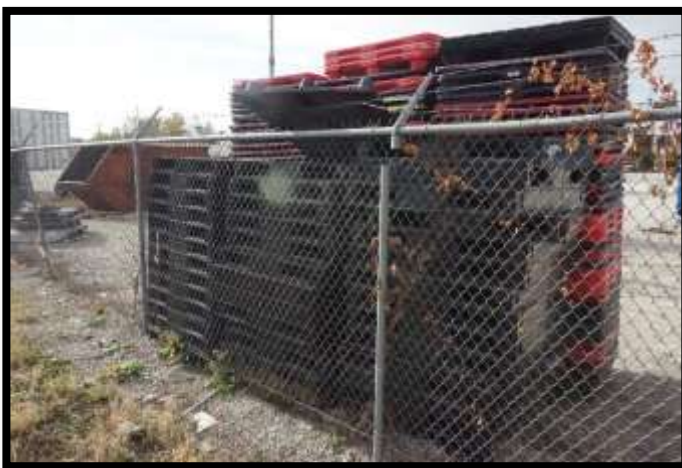
- All Pallet Services, one of the companies that operates on the main industrial site, completed work to repair a bent section of fence (Attachment 5, photographs 30, 31, and 39-41) and to remove most of its pallets from the area near the State Street Warehouse side of the property. There is still some remaining work to be completed in this area, such as repairing a separated fence post (Attachment 5, photographs 40 and 43) and repairing some torn barbed wire (Attachment 5, photographs 42-44), but the condition of the fence is improved and no impacts to the effectiveness of the remedy were observed.

Photograph 40: Fence along State Street Warehouse storage area, straightened fence, and broken fence pole.

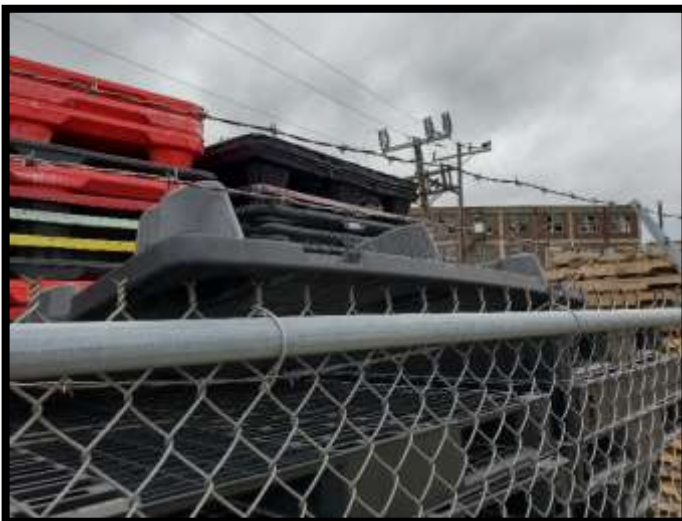
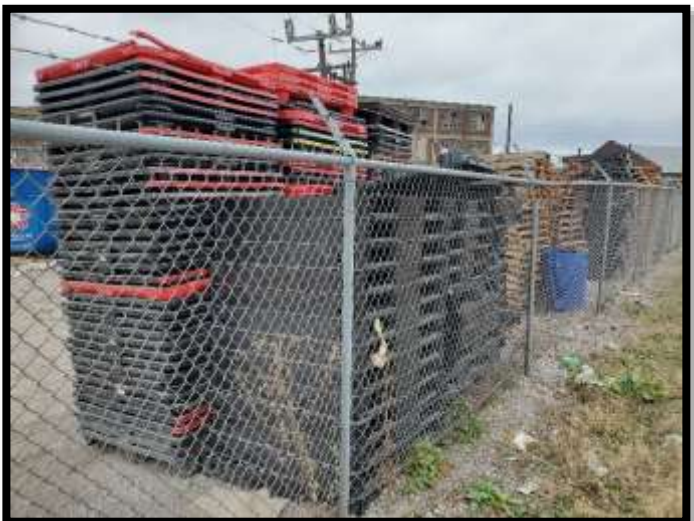
- 1555 State Street and Taracorp Pile property – as indicated above, Mr. Miller assisted in the removal of a plastic pallet from the pallet recycling company that had fallen onto the barbed wire on the top of the perimeter security fence. Photographs 5 and 6 in Attachment 8 show the fence after we removed the plastic pallet from the barbed wire.

Photographs 5 and 6: Taracorp pile – plastic pallet removed from top of fence/barbed wire along All Pallet Services facility.

- One of the four metal fasteners that is used to connect one of the warning signs to the fence along State Street was missing. A fastener was purchased and installed on November 9, 2020 to address this condition.
- With assistance from Mr. Miller on November 10, 2020, a plastic pallet was removed from the top of the fence along the All Pallet Services/State Street Warehouse side of the Taracorp pile property (Attachment 8, photographs 5 and 6).

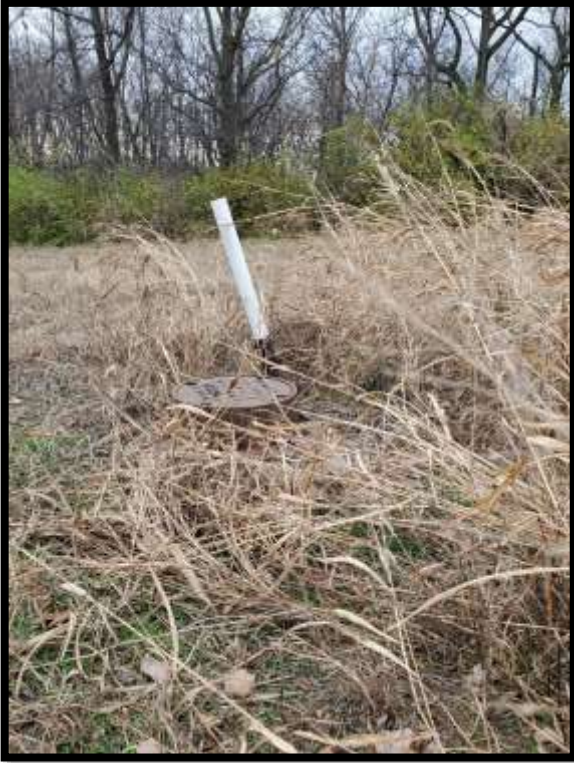
- The sanitary sewer manhole was measured to be about 1,028 feet from the Route 3 barricades. Scattered battery chips were observed in an area of about 50 feet x 25 feet around the sanitary sewer manhole (Attachment 8, photograph 7).

Photograph 7: Schaeffer Road – field near sanitary sewer manhole.

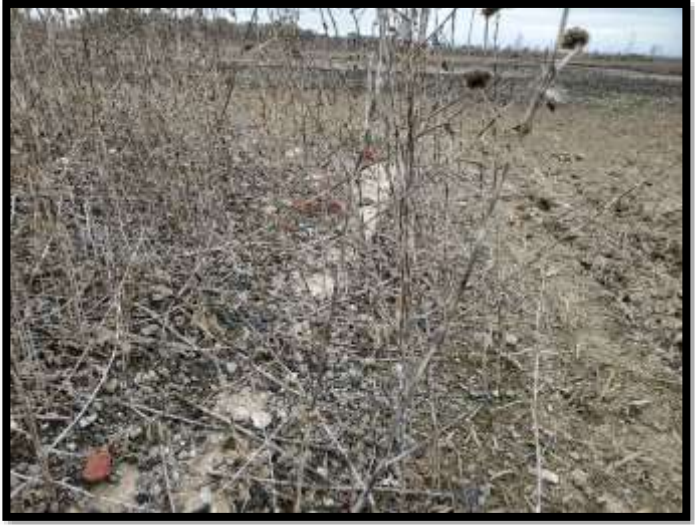
- Most of the scattered battery case chips (Attachment 8, photograph 11) on the soil surface area are located inside the concrete foundation.
  - Some scattered battery case chips were observed in the surface soil about 2 feet outside the concrete foundation on the west side (Attachment 8, photographs 8 and 9).

Photograph 9: Sand Road – concrete foundation (west side).

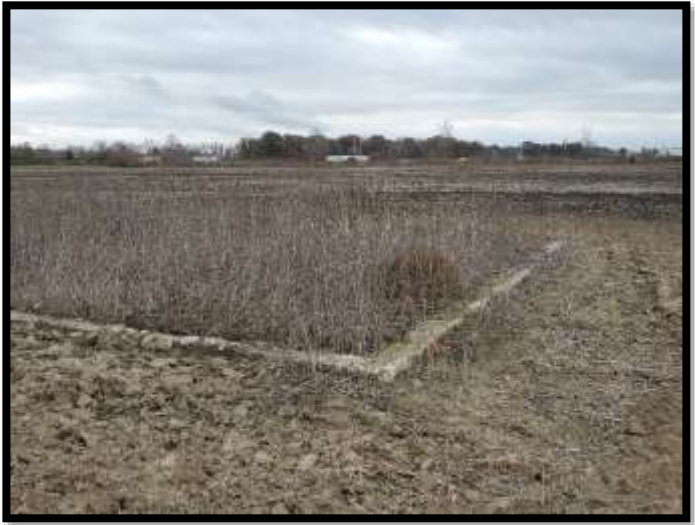
- Sand Road
  - The concrete foundation (Attachment 8, photograph 10) of the former building on the Sand Road property is a rectangle that measures about 29 feet x 38 feet.

Photograph 10: Sand Road – concrete foundation (north and west sides).

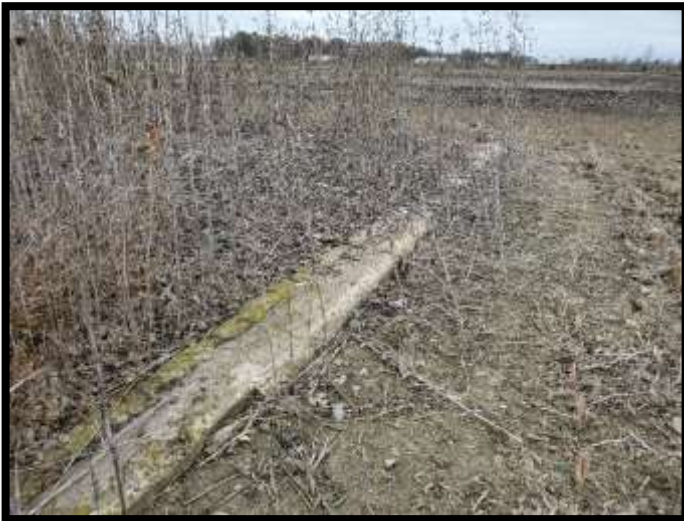
Photograph 8: Sand Road – concrete foundation (west side).

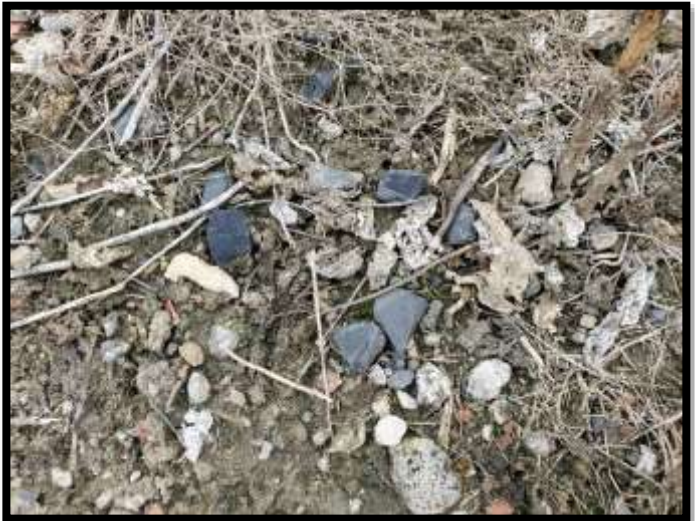
Photograph 11: Sand Road – battery case chips inside concrete foundation.
